B-HCE Report Number 44-22003 – Pendant Properties, LLC Attachments

Photograph 59

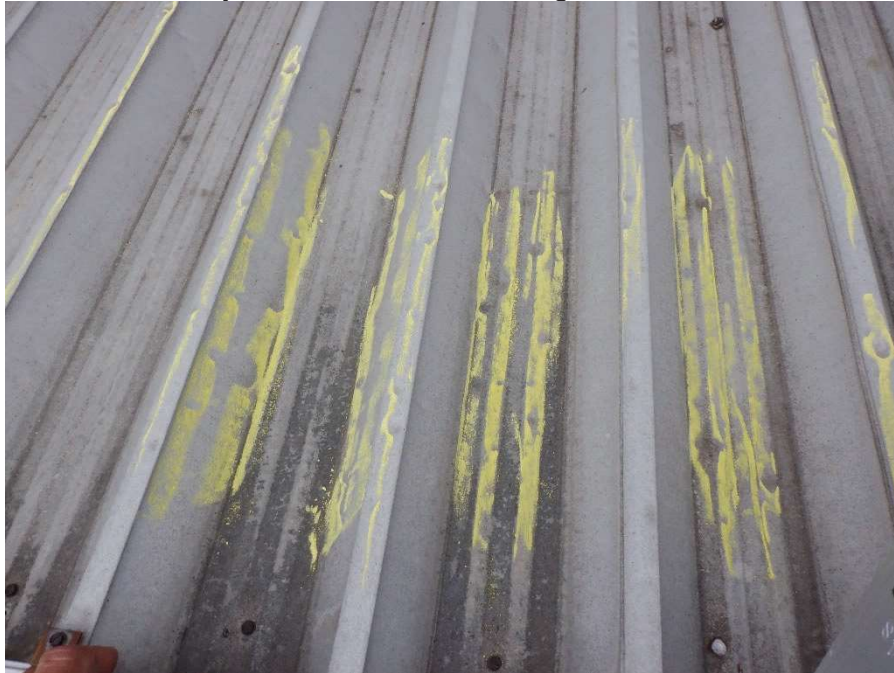
View of the spherical hail-caused indentations in the metal panel awning over the south hallway entrance. Note the larger indentations are not soiled.

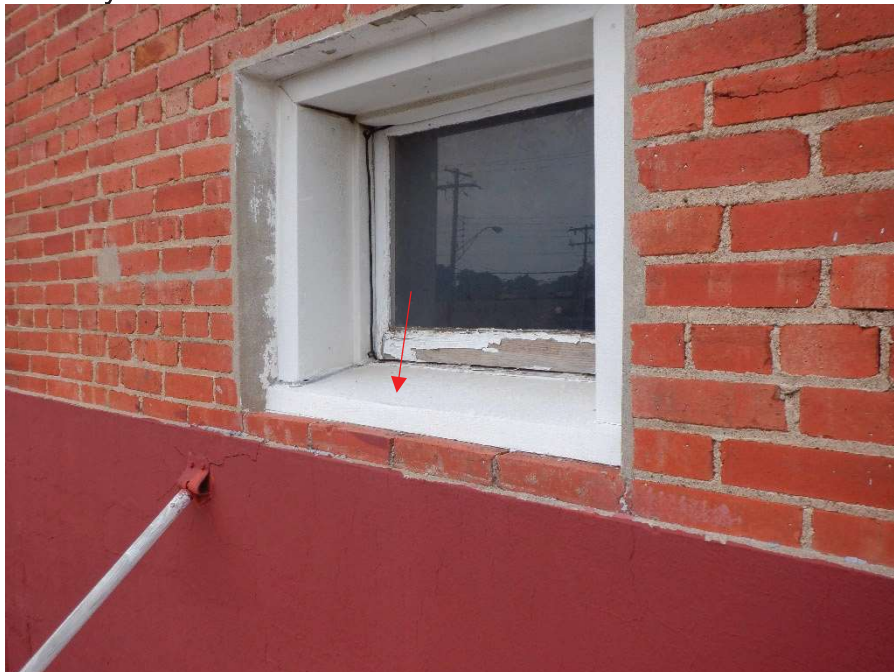
B-HCE Report Number 44-22003 – Pendant Properties, LLC Attachments

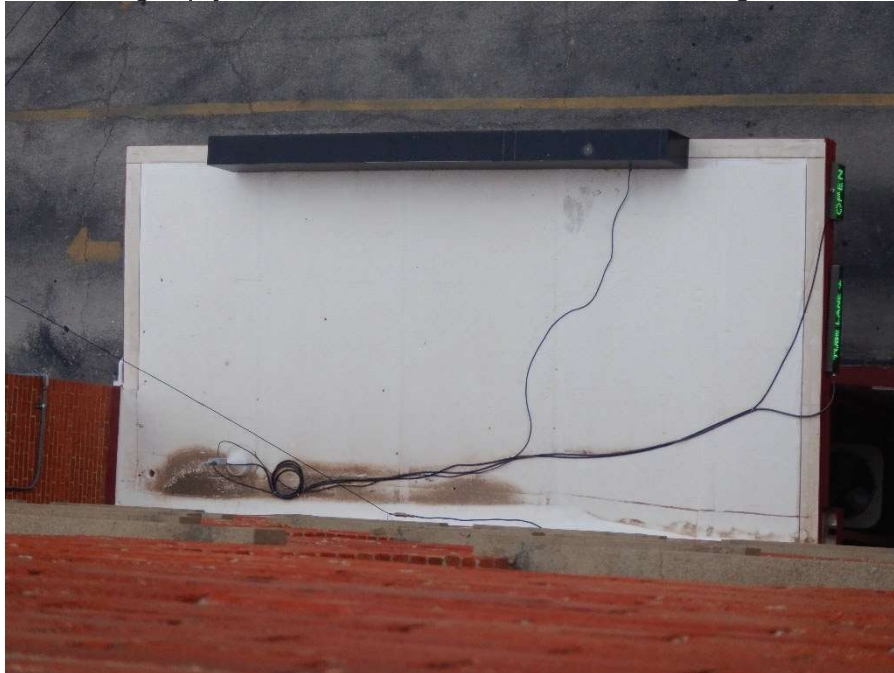
View of the single-ply roof over the bank teller drive through.

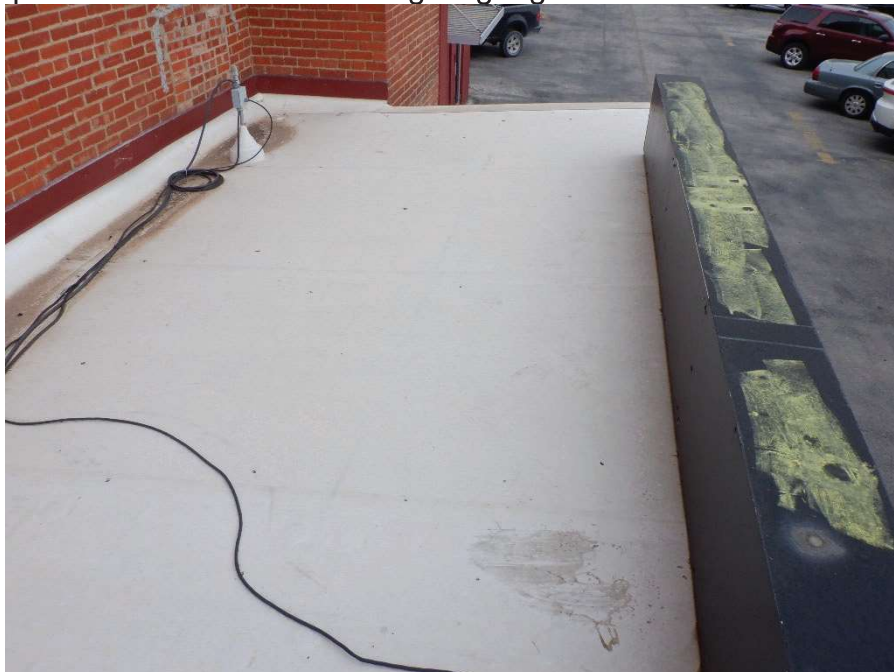
B-HCE Report Number 44-22003 – Pendant Properties, LLC Attachments

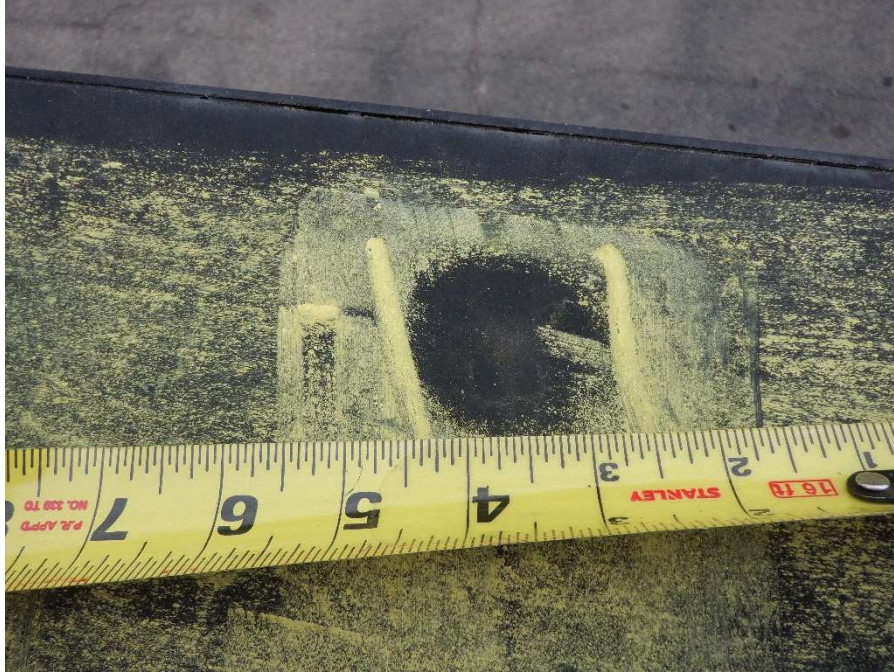
View of typical indentation approximately 1.5 inches in diameter in the metal panel bank teller drive through signage.

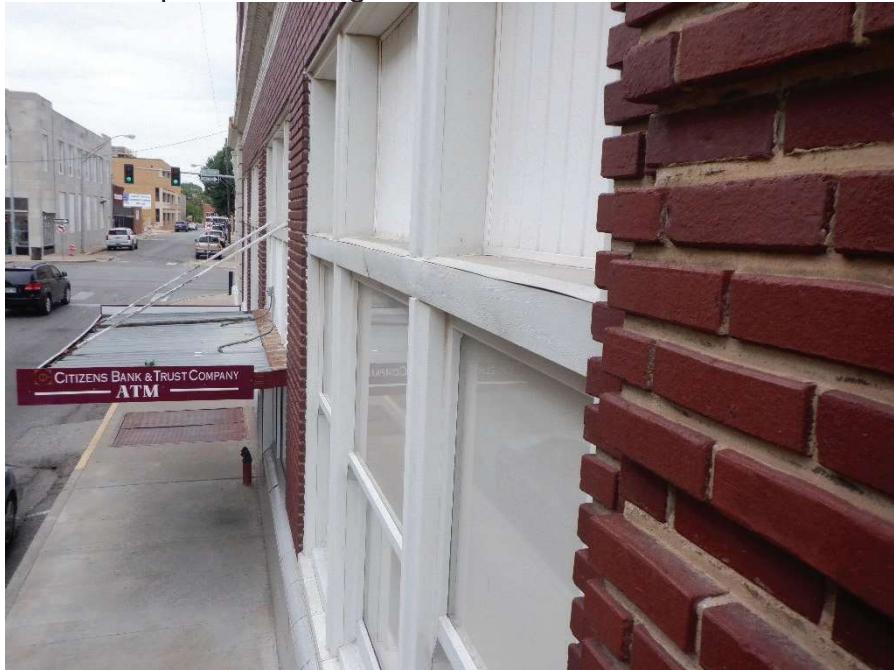
**B-HCE Report Number 44-22003 – Pendant Properties, LLC
Attachments**

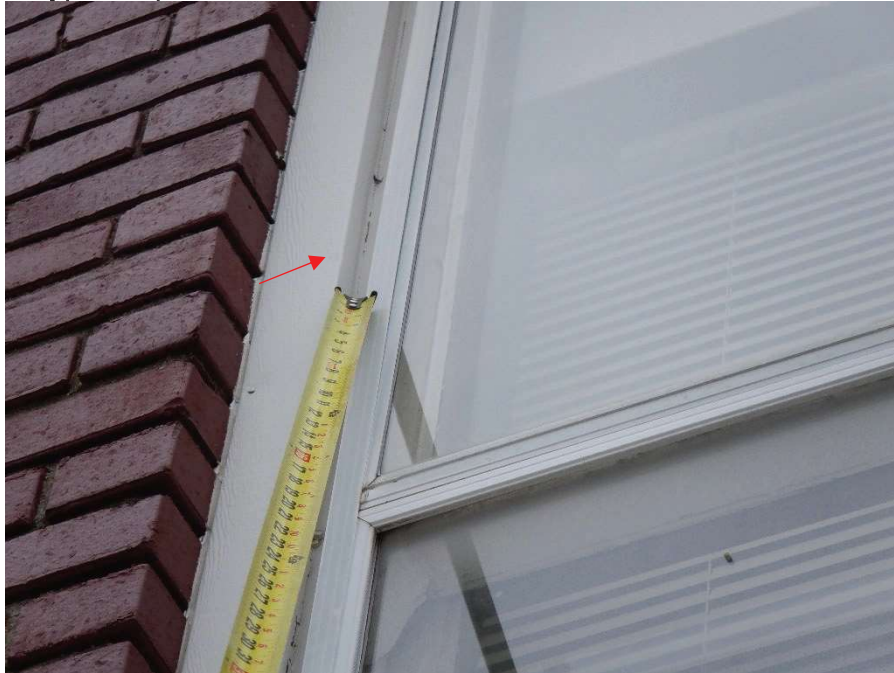
View of typical spherical hail-caused indentation in the window trim.

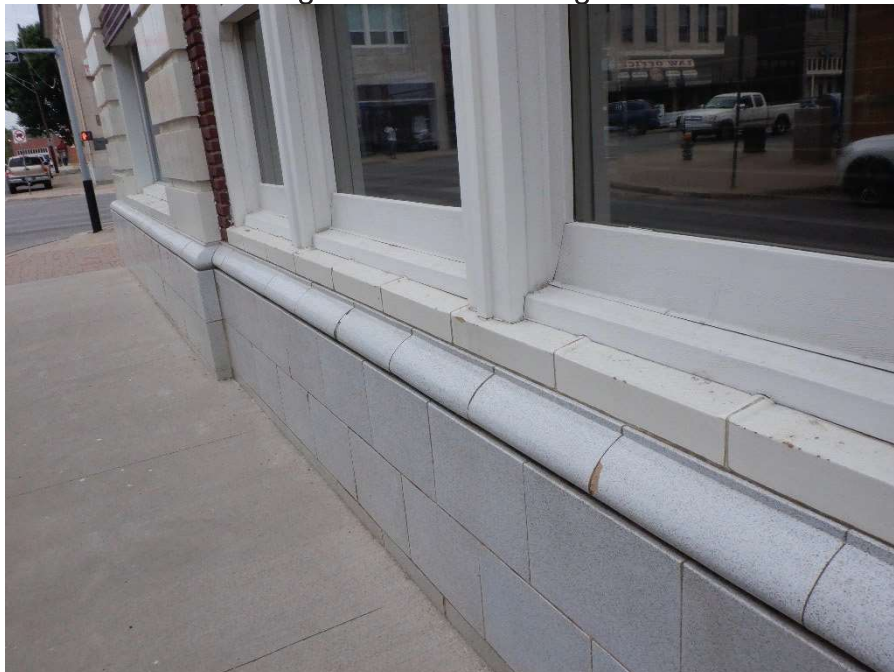
B-HCE Report Number 44-22003 – Pendant Properties, LLC Attachments

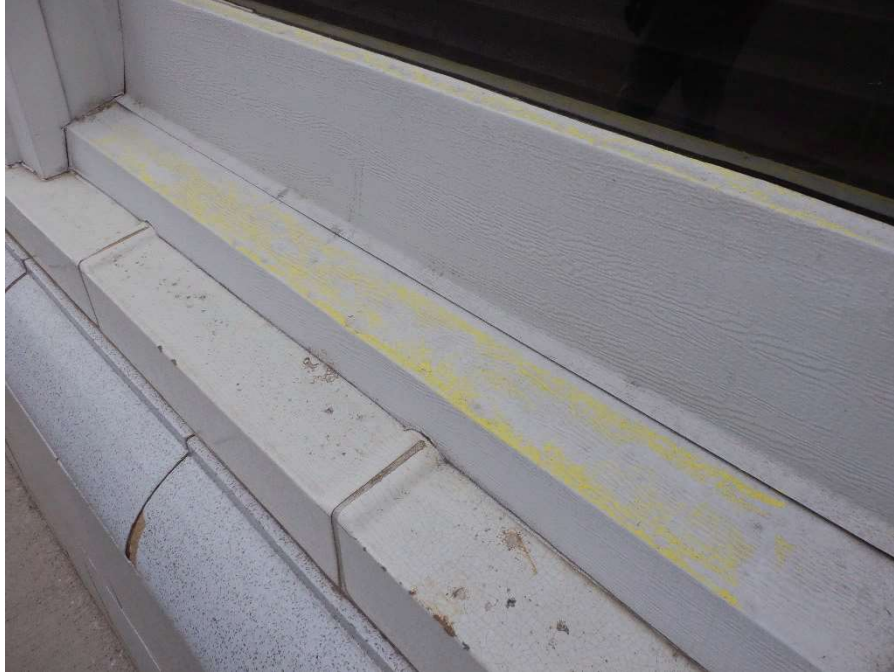
View of the spherical hail-caused indentations in the metal sash around the windows on the west facing side of the building.

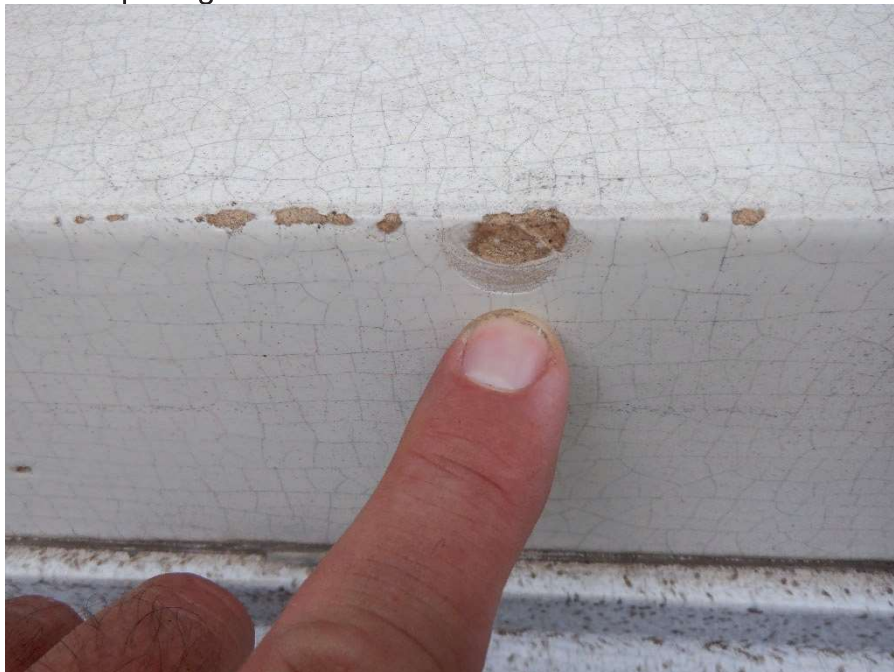
B-HCE Report Number 44-22003 – Pendant Properties, LLC Attachments

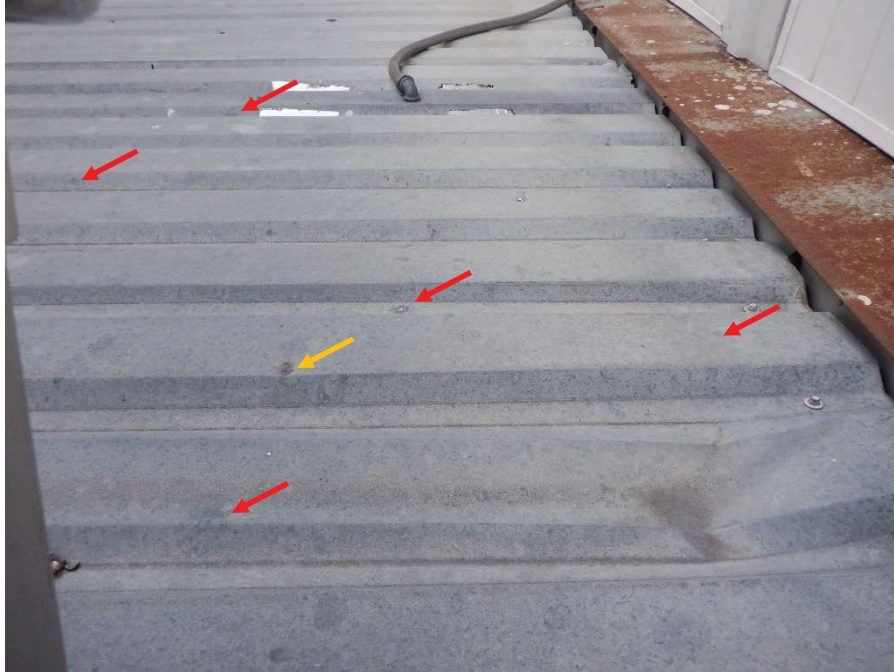
View of the spherical hail-caused indentations with faded burnish marks in the metal panel awning over the ATM. Note only 1 soil filled indentation.

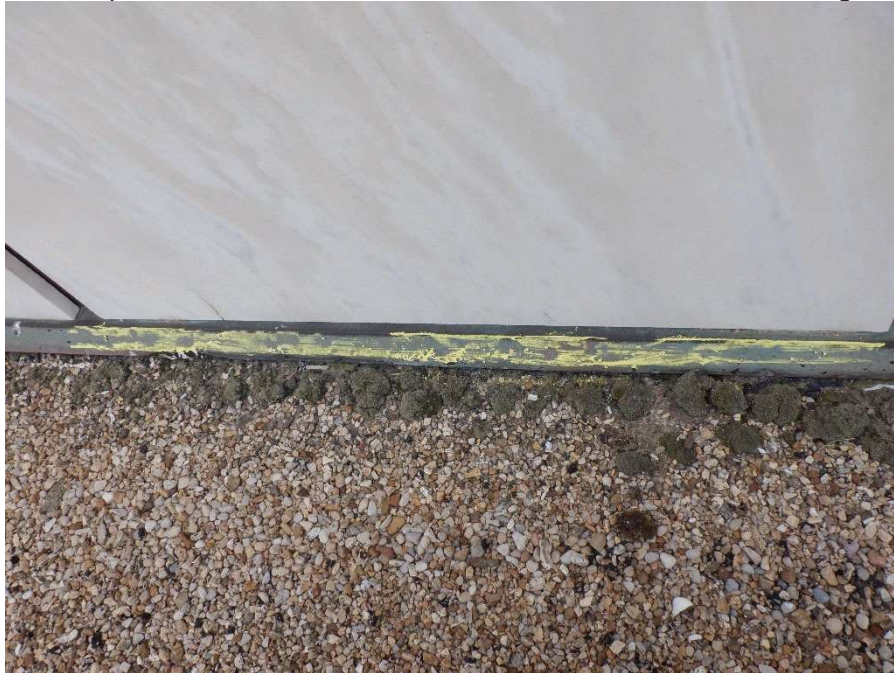
View of the spherical hail-caused indentations in the north awning flashing.

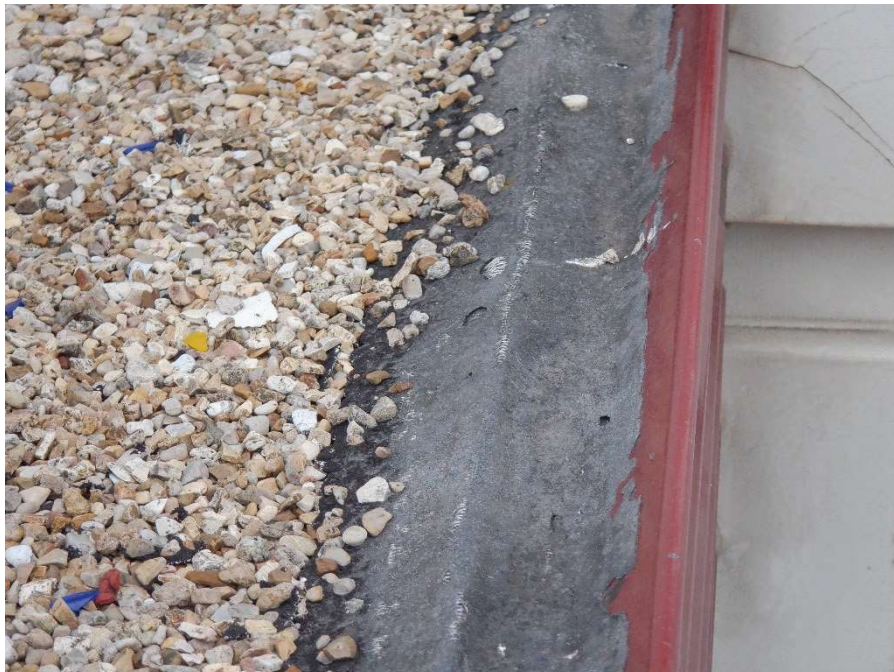
B-HCE Report Number 44-22003 – Pendant Properties, LLC Attachments

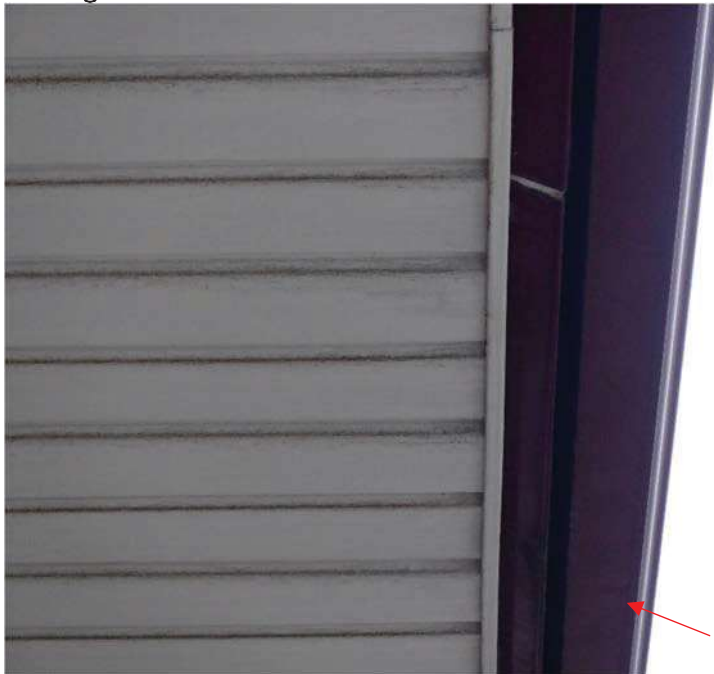
View of typical spherical hail-caused indentation in the gutter along the main front awning.

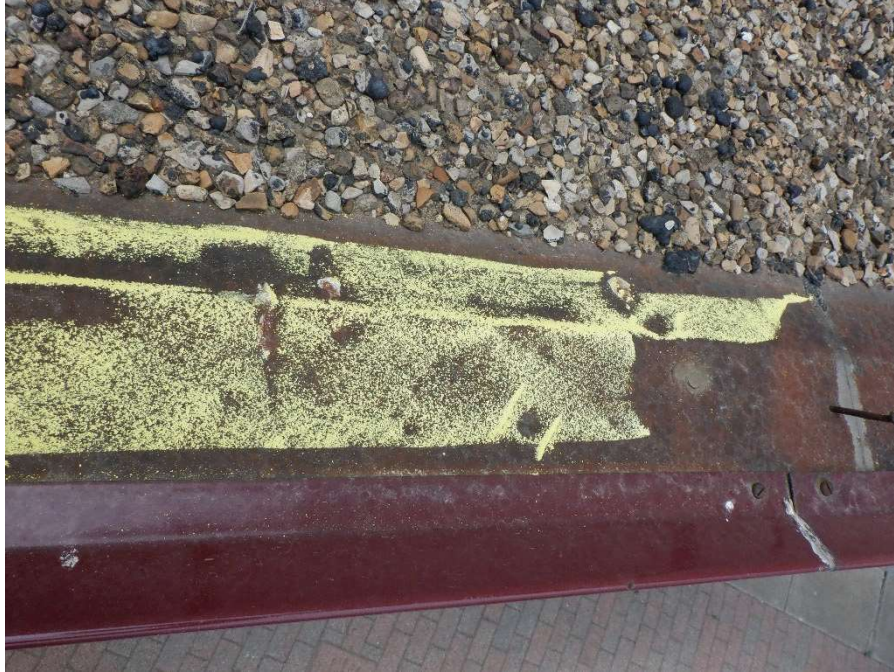
View of typical spherical hail-caused indentations in the perimeter metal flashings along the north awnings.

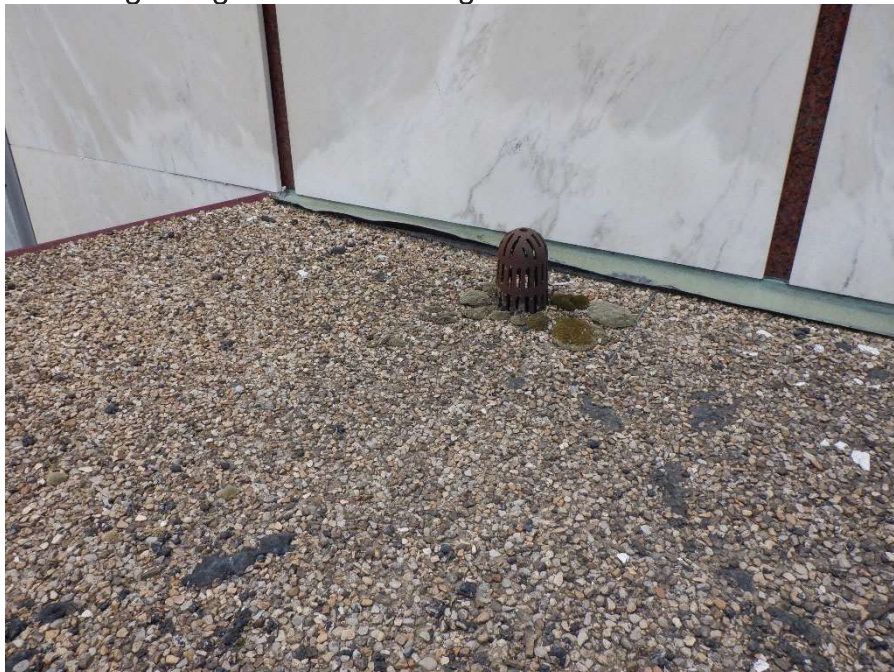
B-HCE Report Number 44-22003 – Pendant Properties, LLC Attachments

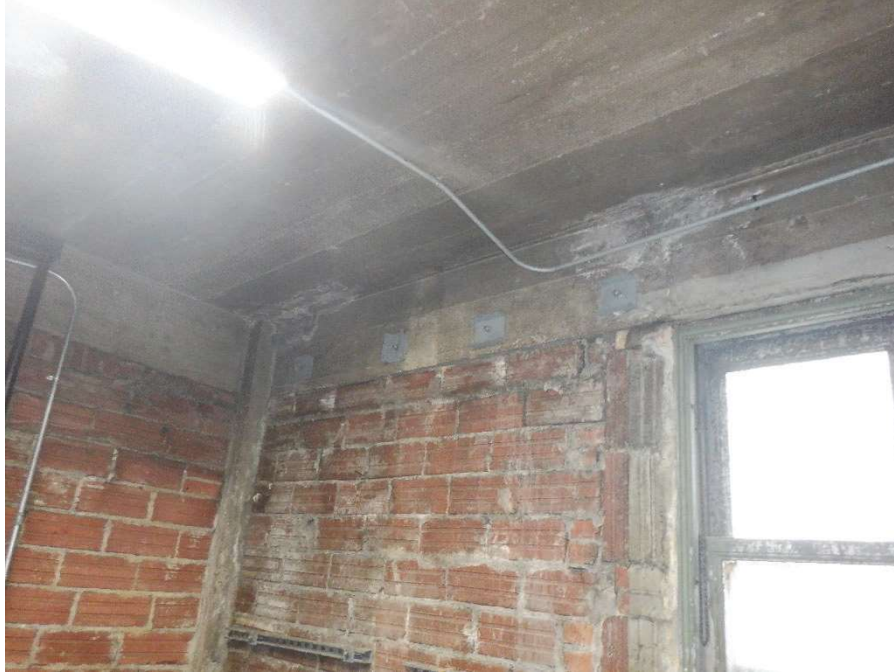
View of the water stains on the penthouse concrete roof deck within the roof access mechanical room consistent with a breached roof.

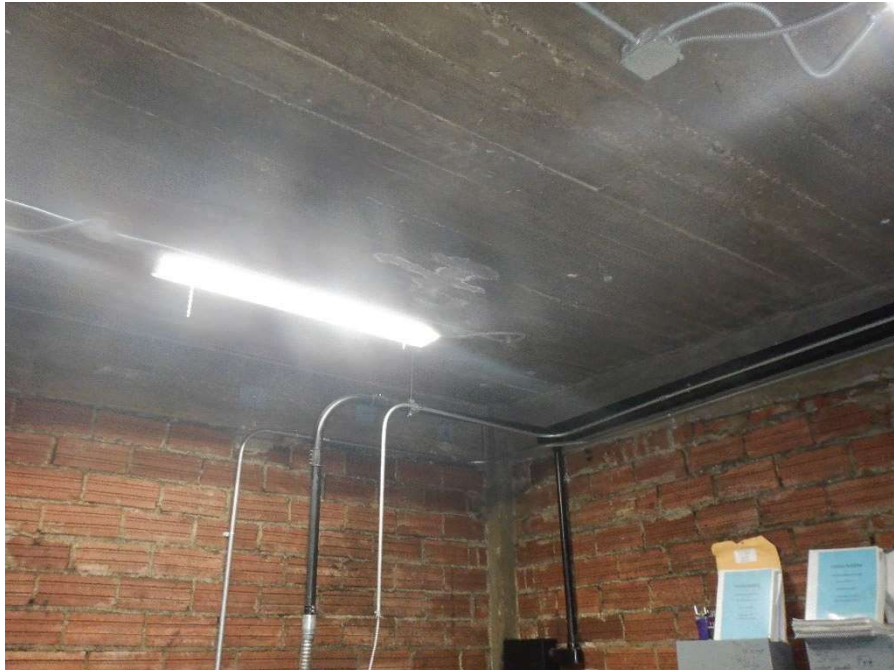
**B-HCE Report Number 44-22003 – Pendant Properties, LLC
Attachments**

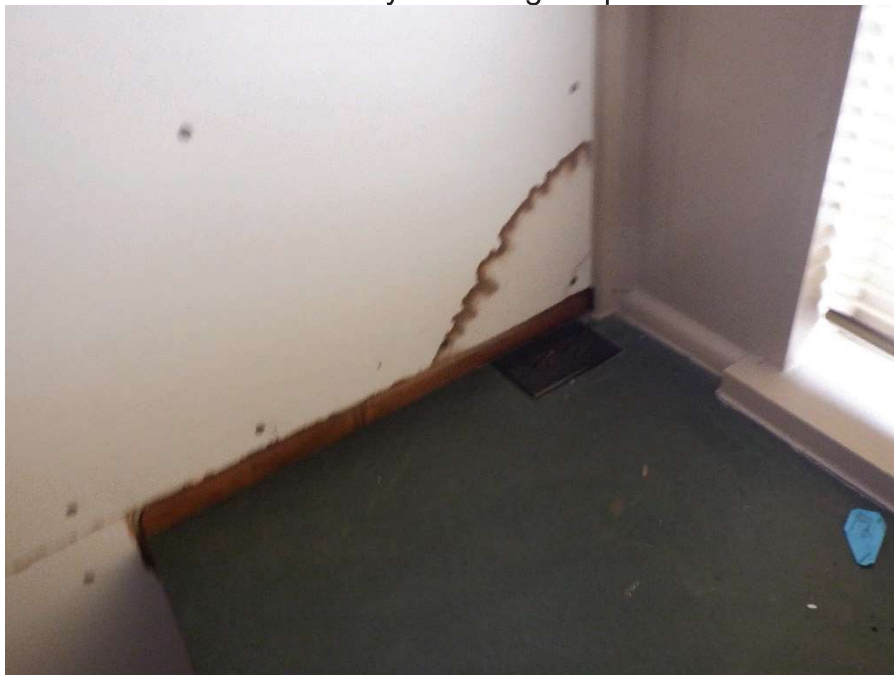
View of the water stains to the drywall along the perimeter wall in suite 616.

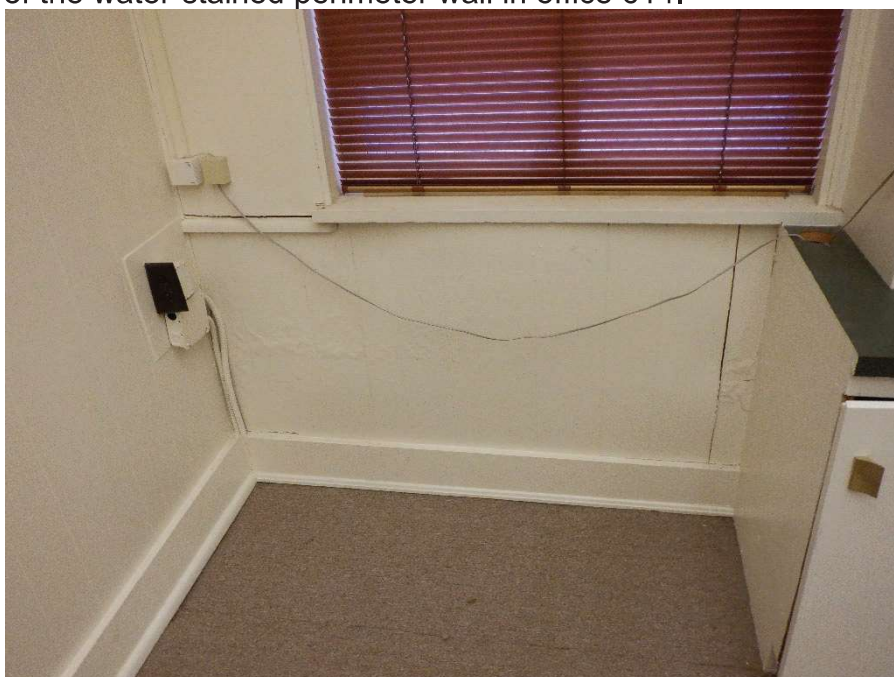
View of the water-stained perimeter wall in office 614.
